Retaining Walls, Retaining History

An Interpretative Account of Richmond's Morphological Marker

Independent Research Project
Dr. Joseli Macedo, Supervisor
Dr. Mikiko Terashima, Instructor
PLAN 6000
December 13, 2019

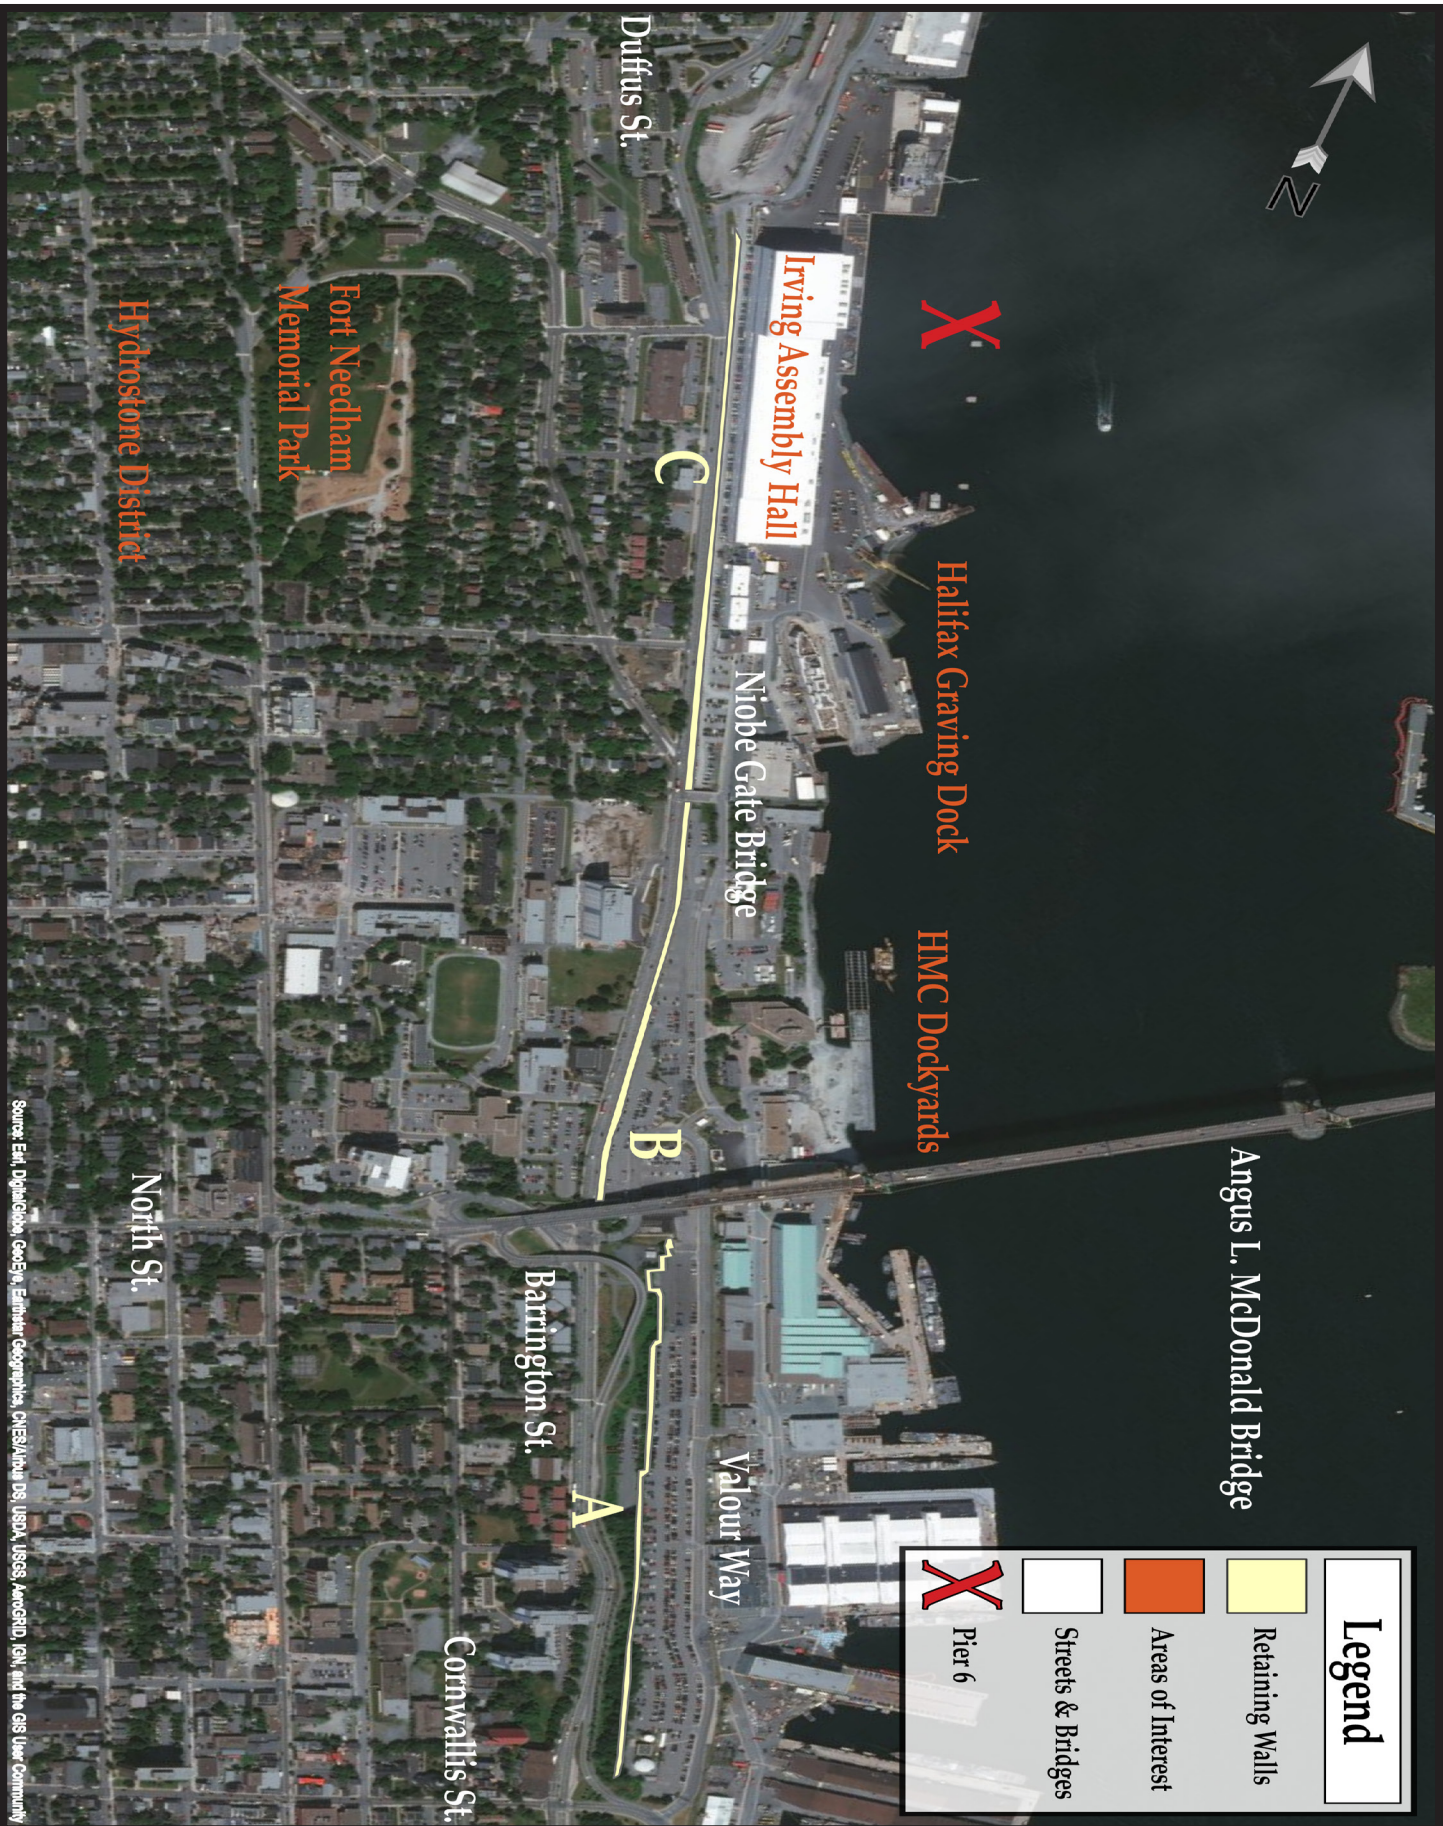
A series of retaining walls were built between Cornwallis and Duffus Streets. The walls themselves were not built contiguously and thus they could be divided into sections (Figure 4).

The second section **(B)** runs between the intersection of North Street and the Niobe Gate Bridge.

The third section **(C)** runs along Barrington Street from the Niobe Gate Bridge to the end of the Irving Assembly Hall near Duffus Street.

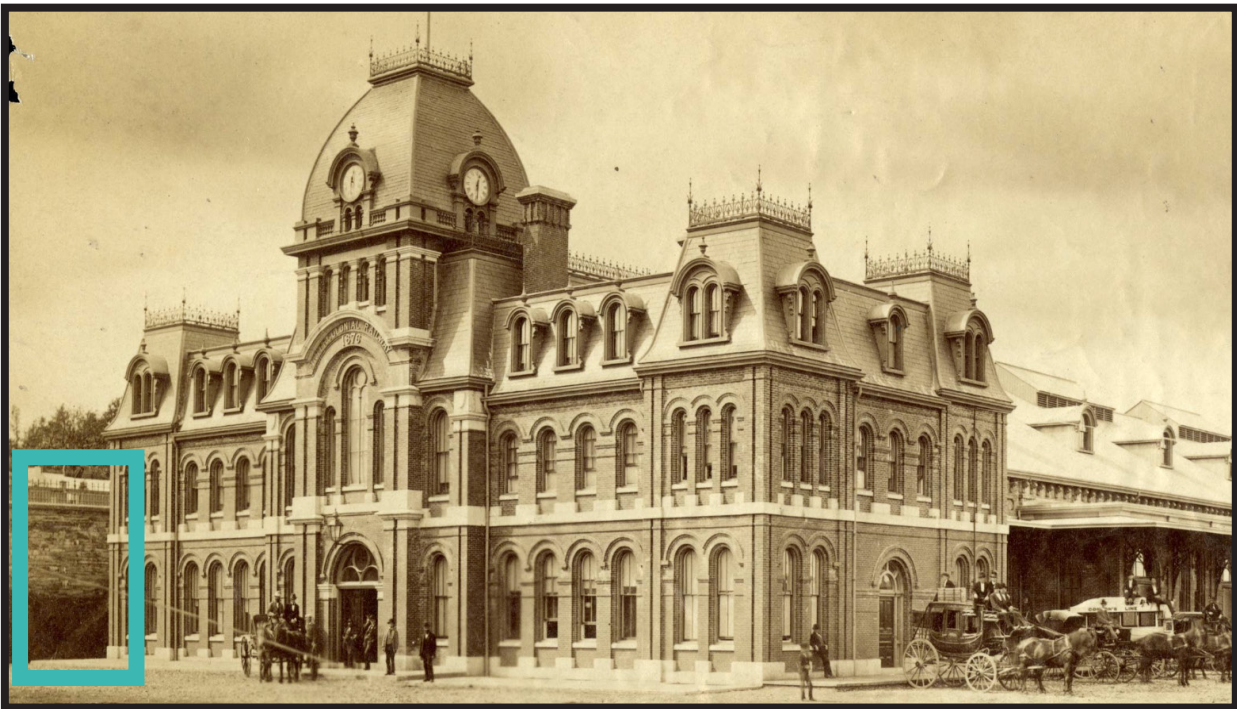
Figure 11: Photograph of the North Street ICR Station, 1902.

This 1902 photograph of the North Street Intercolonial Railway Station shows the splendour of the building with its Second Empire architectural style and the ironstone retaining wall below Barrington Street (highlighted in teal).

This section of the retaining wall system was built between 1874 and 1877 (Figure 11 & 12). This is known because of a record kept by the Canadian Government on the grading and masonry work done. The grading of the land and the masonry work on the heavy ironstone retaining wall from Richmond to North Street was completed by the contractor, Samuel McKean from 1874 to 1877. It came at a cost of \$178,302 (Sessional Papers of the Dominion of Canada, 1878, p. 129). The maps on the following page demonstrate the placement of the ICR station on Barrington Street (Figure 12, 13, & 14). The map from 1895 shows black hatched marks under the word "Lockman" which indicate where the retaining wall stood. By 1967, the station and the bridge connecting Upper Water Street to Barrington Street do not appear on the map as they were demolished (Figure 14).

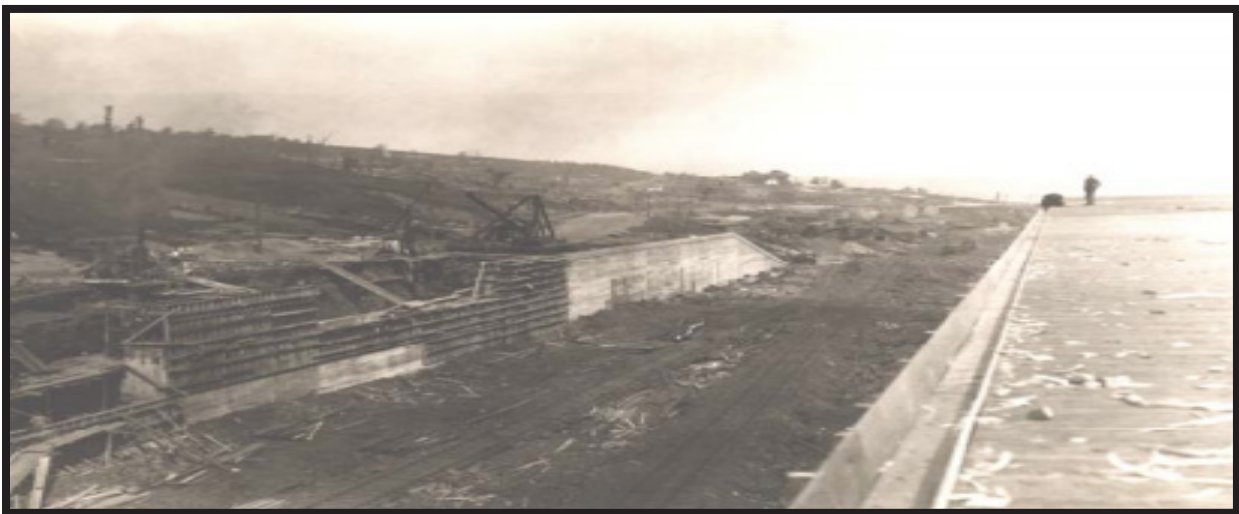
Figure 15: Photograph of the construction of the retaining wall, 1918.

This section of the retaining wall system was built in the summer of 1918 after the Halifax Explosion (Figure 15). Railway contractors, Cavicchi and Pegano were contracted by the Halifax Relief Commission to build the wall from high-strength concrete. It still exists today at the site in a relatively intact form, although the railway right-of-way seen in the 1967 map does not exist anymore, having been replaced with a parking lot for the HMC Dockyard (Figure 16).

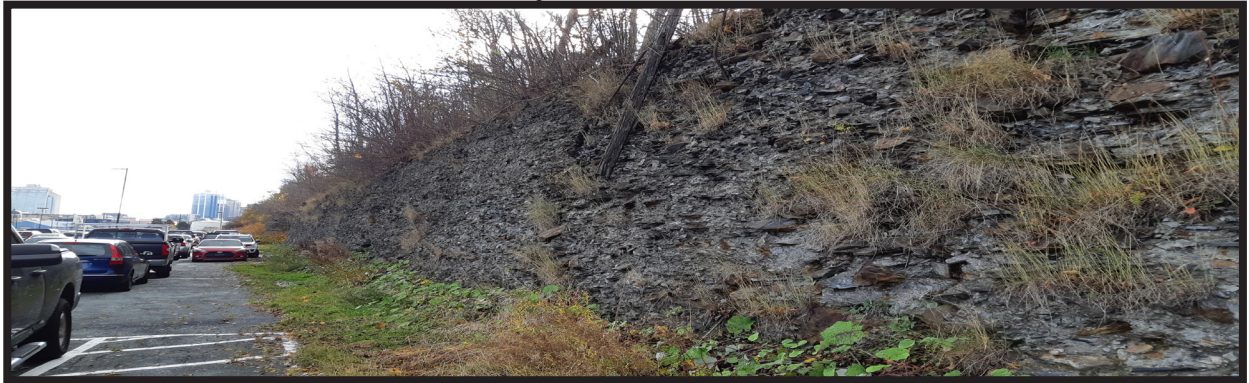
Figure 17: Photograph of the retaining wall along the HMC Dockyard parking lot.
(Source: Maenza, 2019)

The concrete wall shows signs of heavy wear with multiple long cracks, chips, and discolouration. Efflorescence (a salt residue) appears as a chalkish-white colour due to moisture from rain reacting with the concrete. Traces of rust appear from the ironstone rip-rap behind the wall. Seasonally, the wall supports bulrushes and marsh-like conditions at its base (Narratives in Space+Time Society, 2016).

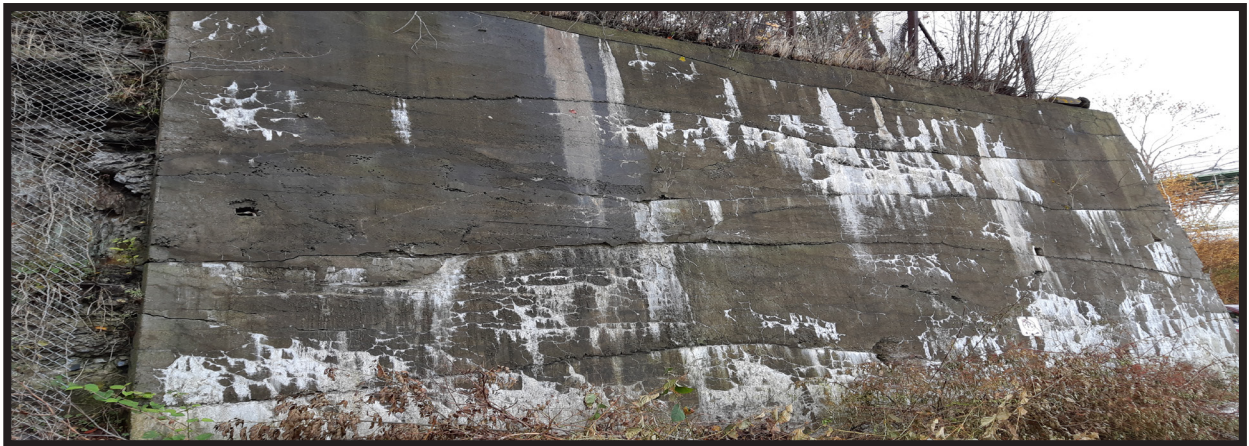
Figure 18: Photograph of the North Street ICR Station, 1902.
(Source: Maenza, 2019)

For much of this retaining wall section, the concrete wall indicated on the old fire insurance map (Figure 10) is not apparent. Instead, the fill of crushed rock and rip-rap that was located behind the concrete wall has been exposed and it extends for much of the section (Figure 18). Near the footing of the Angus L. Macdonald Bridge, the concrete wall section indicated on the maps appears (Figure 18).

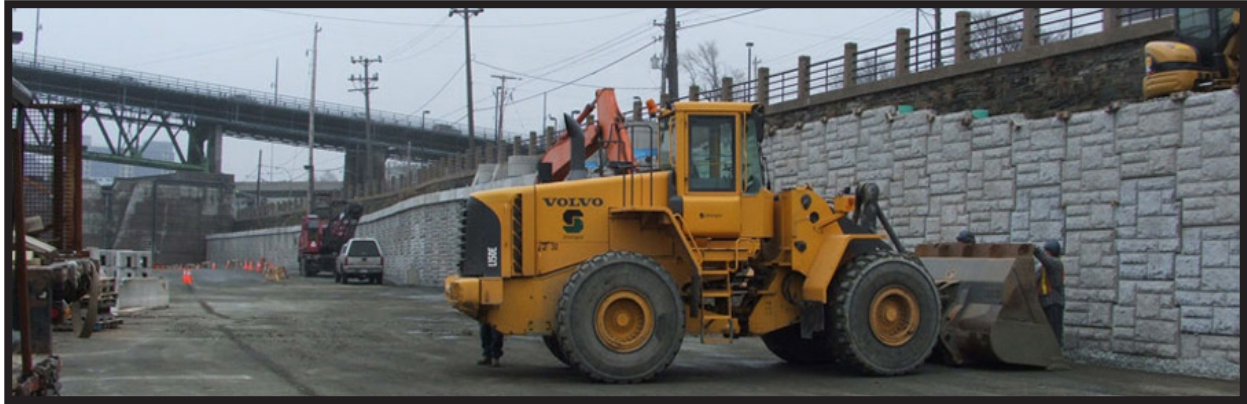
Figure 19: Photograph of the old masonry and new concrete retaining walls.
(Source: Alva Construction Ltd, n.d.)

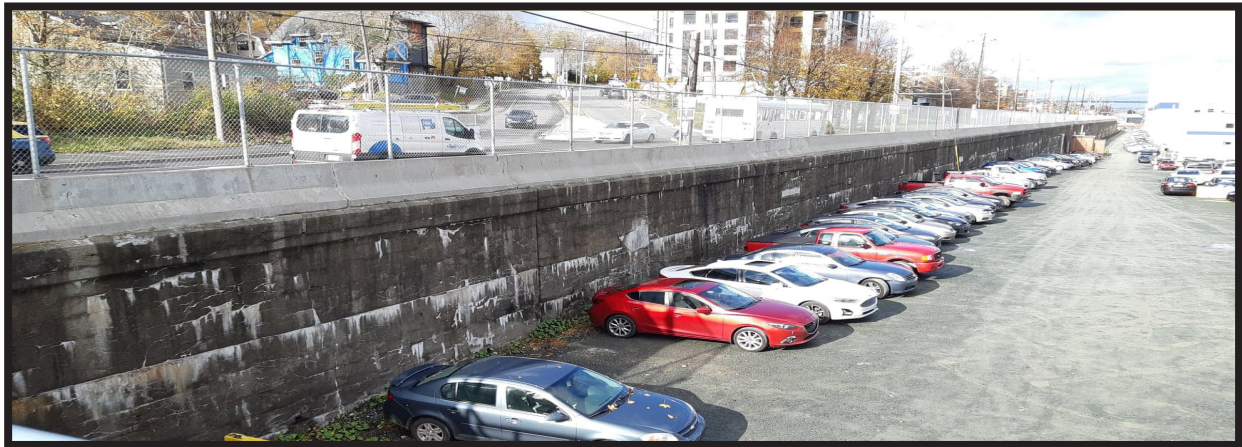
Figure : Photograph of the concrete retaining wall along the Irving Shipyards.
(Source: Maenza, 2019)

The concrete wall shows signs of heavy wear with multiple long cracks, chips, and discolouration. Efflorescence (a salt residue) appears as a chalkish-white colour due to moisture from rain reacting with the concrete (Figure 20). Traces of rust appear from the ironstone rip-rap behind the wall. Unlike the 1909 wall near Valour Way, the retaining wall on Barrington St is positioned much more vertically without a sloping angle.

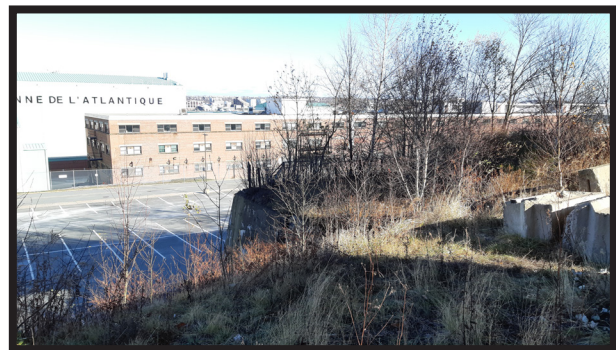
Figure 43: Current view of the area.
(Source: Maenza, 2019)

The dwellings were demolished and a grassy area was left in its place. The retaining wall stands directly below (Figure 43). It is unknown if at the time of the expropriation any consideration was given to any potential archeological resources that may still lie buried in the ground.

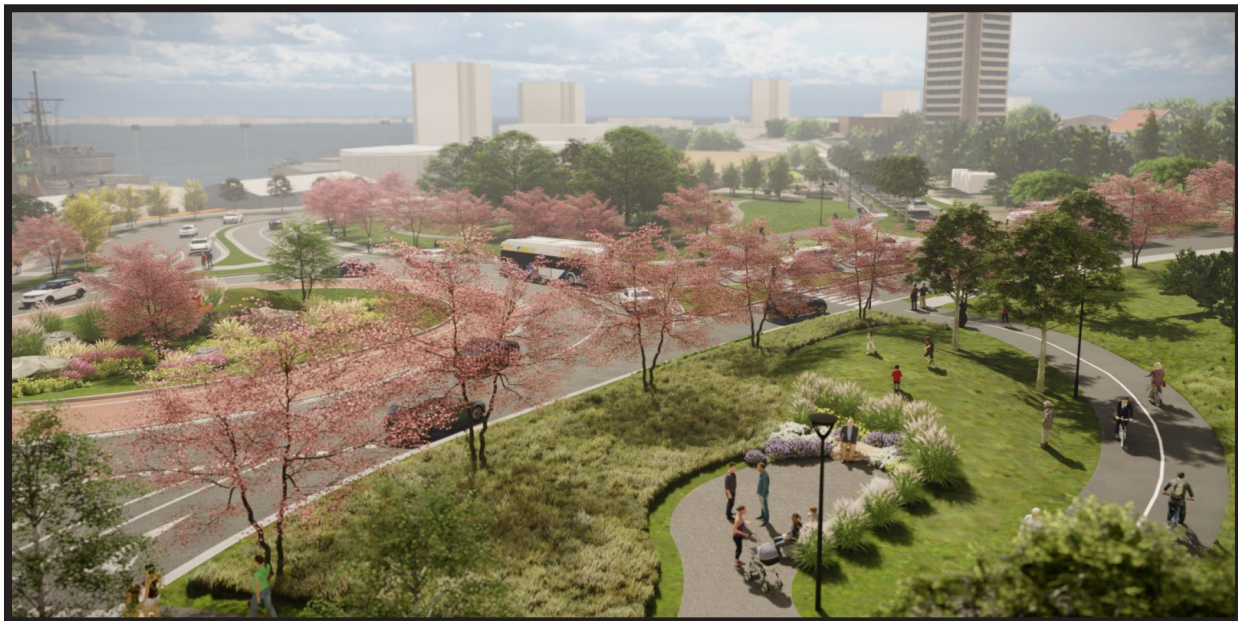
Figure 53: Rendering of the roundabout site demonstrating a slight slope on the left side.
(Source: HRM, 2019-b, p. 24)

The Cogswell District suffers from issues of inactive ground floor uses (surface parking lots) and tough topographical challenges due to a steep slope towards the water's edge. The construction of the roundabout will require a re-grading of the land near the Halifax Water wastewater treatment plant, demolition of properties along Barrington Street and section A of the retaining wall within DND property (Figure 52 & 53).

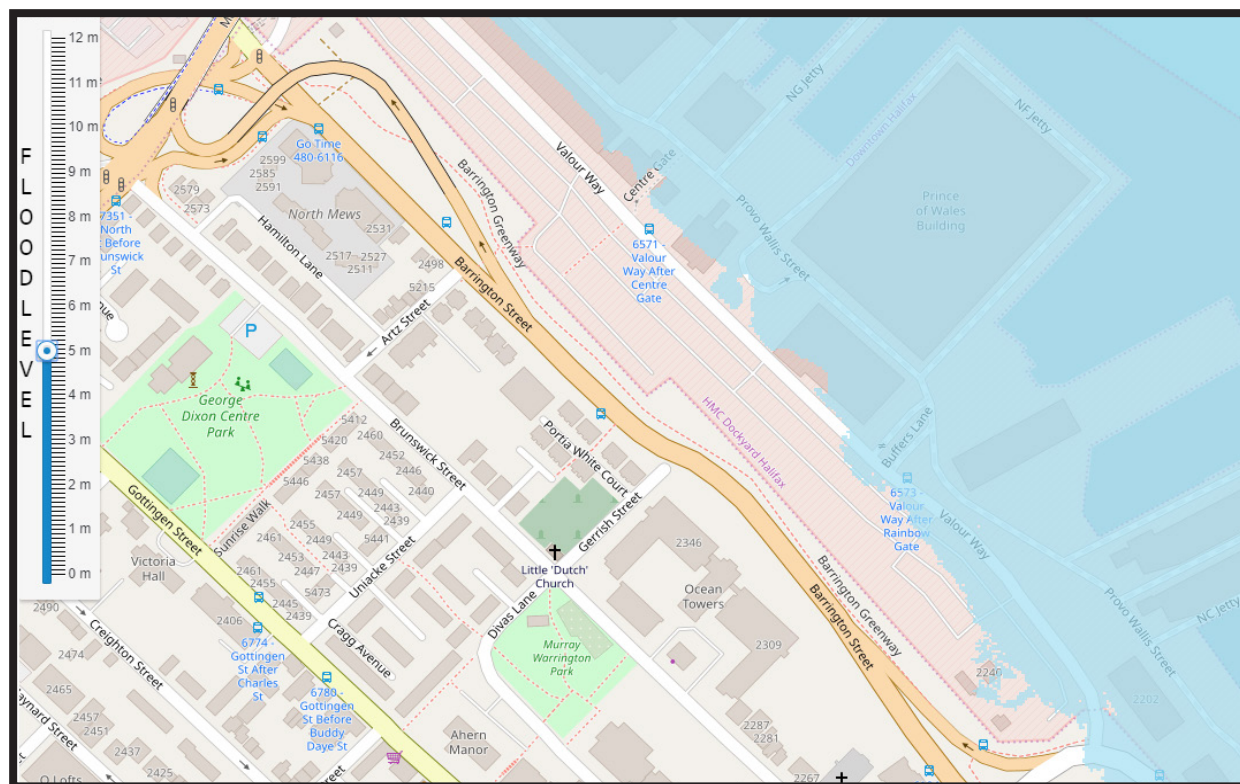
Figure 54: Sea level rise at 5 metres on section A of the retaining wall system, 2019.
(Source: Applied Geomatics Research Group, 2019. Maritime Coastal Flood Risk Map. NSCC)

The Applied Research Geomatics Group (APRG) at NSCC has been working for over a decade on creating high-quality flood risk maps for communities throughout Nova Scotia. In the case of the HRM, the group has been using LIDAR 1-2 metre elevation imagery to assess which areas of the city are at high risk. They have produced a series of maps that display data on sea-level rise at different floodlevels and a tsunami map (Figure 54 & 55). In correspondence with Dr. Boxall, it was noted that the impacts of the massing of buildings and the way the retaining walls may refract and push water away has not been fully explored through the modelling used by the APRG (Boxall, personal communication, 2019).

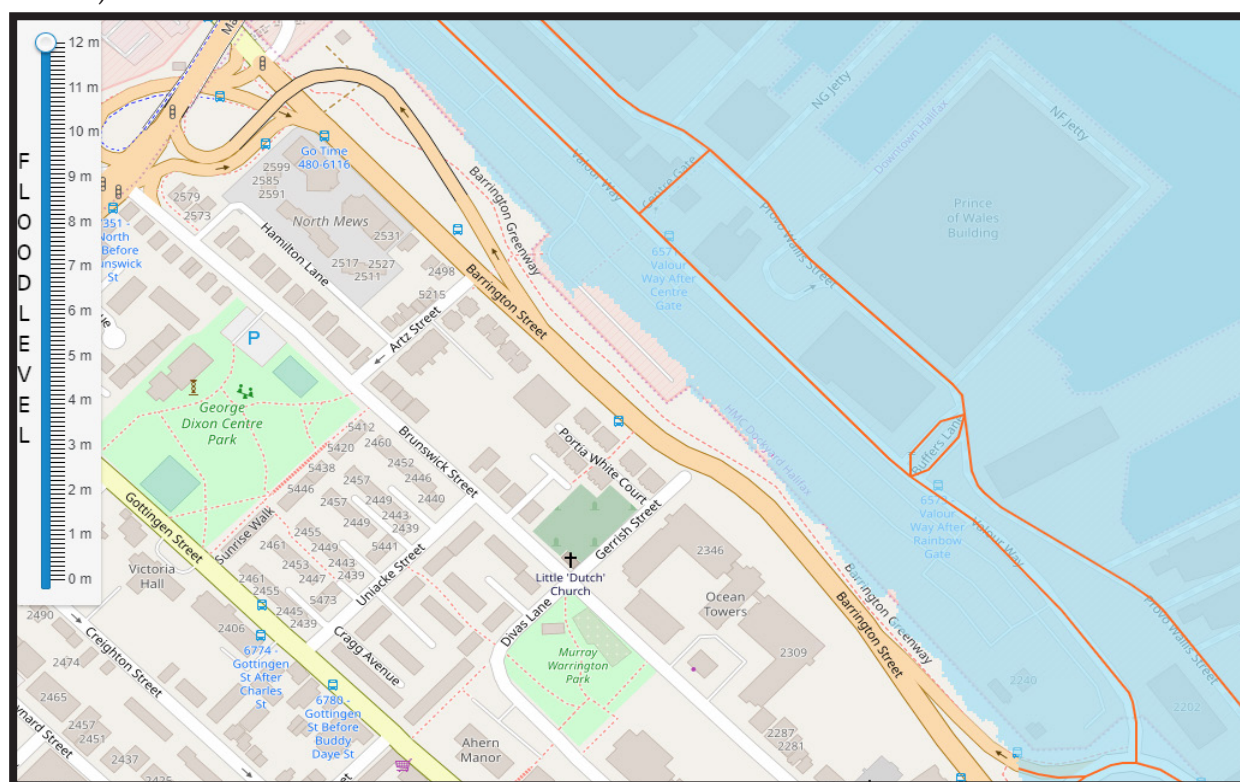
Figure 55: Sea level rise at 12 metres on section A of the retaining wall system, 2019.
(Source: Applied Geomatics Research Group, 2019. Maritime Coastal Flood Risk Map. NSCC)

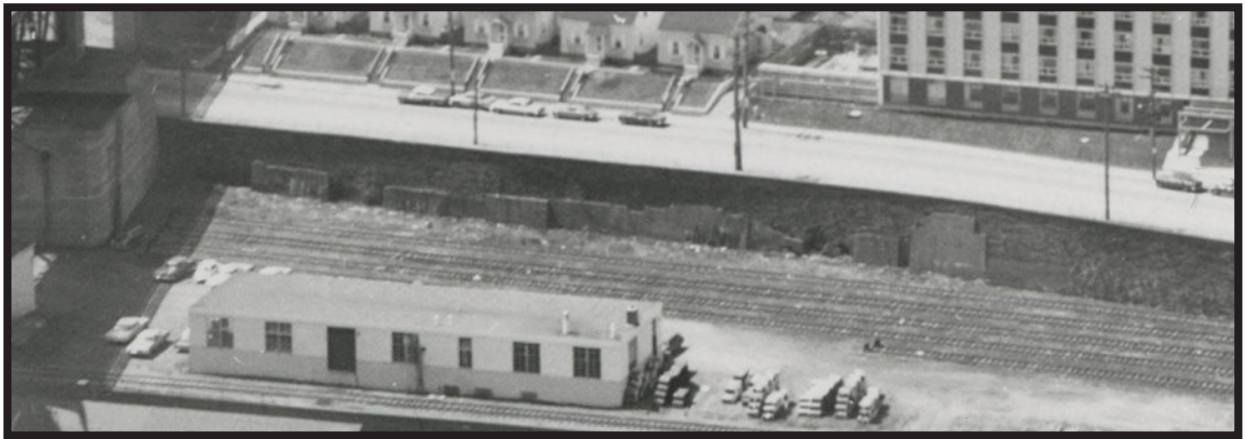
Figure 58: Photograph of the masonry retaining wall below Barrington Street, 1960s.

The Department of National Defence (DND) owns the retaining wall section between North Street and the Niobe Gate Bridge (section B). As previously discussed, it originally was a masonry ironstone retaining wall that supported the roadbed of Barrington Street from its construction in the 1870s. It has been repaired over the last one-hundred years as large concrete blocks have come to be layered over section of the original wall (Figure 58 & 59).

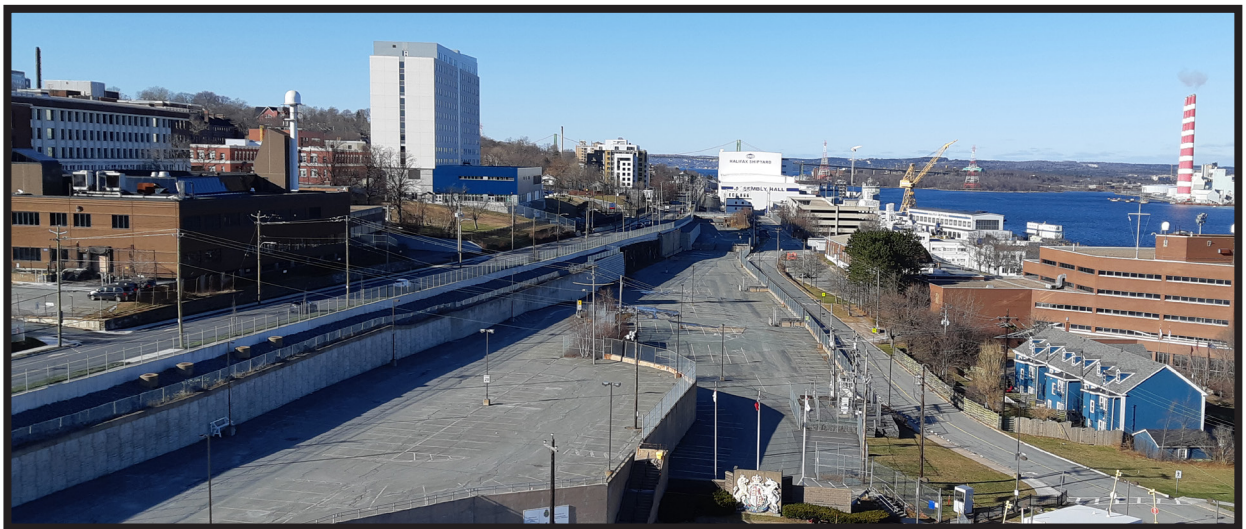
Figure 59: Photograph of the new retaining wall structure, 2019.

View of the concrete retaining wall within the Halifax Dockyard. It has been patched with concrete and buffered out into a pair of terraced walls. The masonry wall lies behind the new concrete wall. Note the loss of the railway tracks in the 1980s replaced with a parking lot.

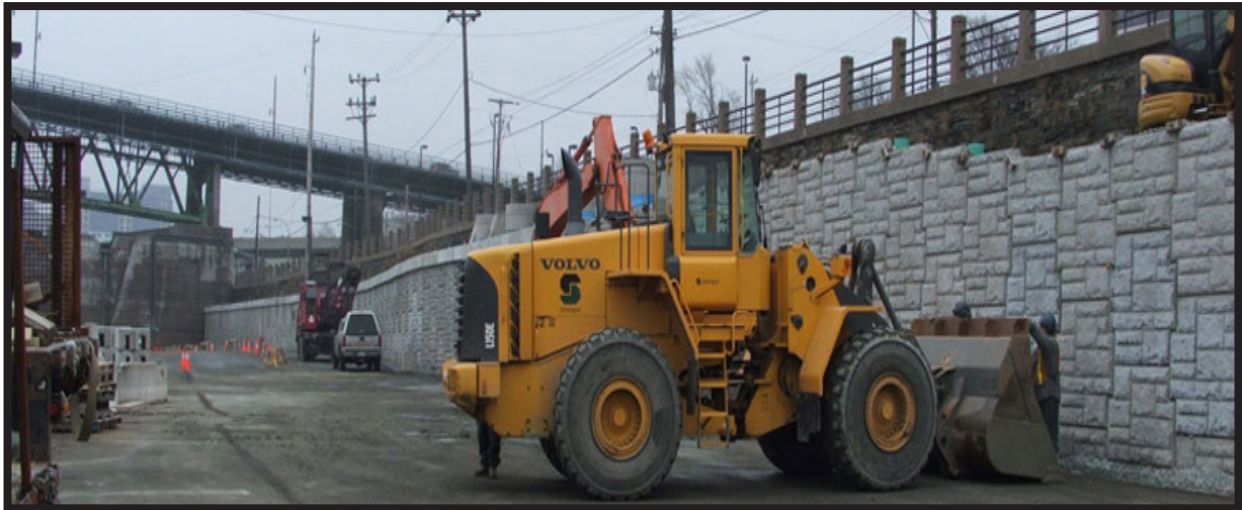
Figure 61: Photograph of the construction of the new retaining wall, 2016-2017. Construction of the new retaining wall in front of the old masonry wall from the 1870s. The rock bolts and pre-cut concrete blocks are visible. Where the current barrier lies, a concrete cap was fastened to the old masonry wall.

Over the last ten years, the DND sought to reconstruct and stabilize that section of wall. In order to do this, several agreements and assessments between the HRM, the Canadian Environmental Assessment Agency, and the DND were signed. In 2009, the DND determined that it needed an environmental assessment to be completed in relation to its plans to reconstruct and stabilize the retaining wall. As noted in the project description, the work involved the construction of 290 metres of a new reinforced concrete retaining wall within the HMC Dockyard parking lot, adjacent to Barrington Street. Standing 6.5 metres tall, it was built directly in front of the old deteriorating masonry wall. One metre of excavation was required to construct the new concrete footings and to install a drain behind the wall. Around 1,750 cubic metres of acid-generating pyritic slate was encapsulated behind the new wall so that water run-off would not contaminate the area. The new section of the retaining wall was built between 2016 and 2017 by Alva Construction Ltd, a contractor from Antigonish, N.S. (Figure 61) (Alva Construction Ltd, n.d; Canadian Environmental Assessment Agency, 2012; Global News, 2017).

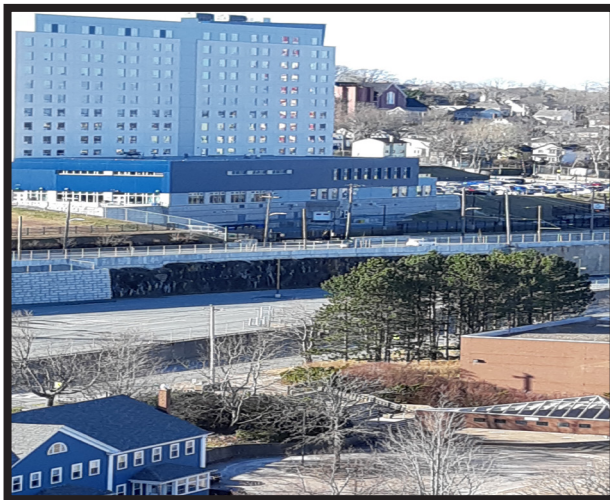
Figure 62: Photograph of wall, 2019.
(Source: Maenza, 2019)

As around 290 metres of new retaining wall had been constructed, not all of the 1870s masonry wall has been covered over. One section still exists visible to the eye and open to the impacts of the weather (Figure 62 & 63).

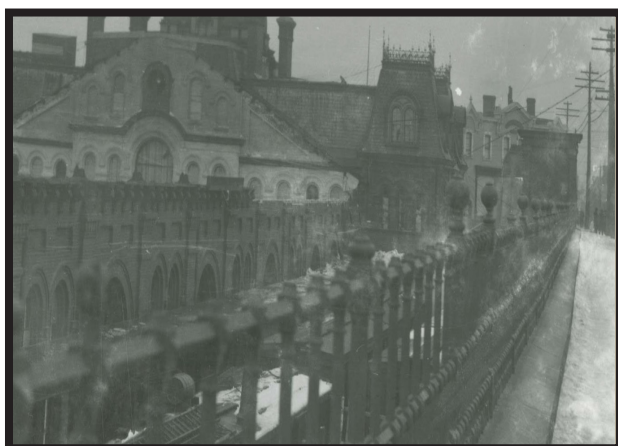
Figure 64: Handrails of the wall, 1917.
(Source: Notman Studio, 1917, Nova Scotia Archives, no. 1983-310, No. 41)

The old iron handrails of the retaining wall were originally from 1876 (Figure 11 & 23). Beautifully constructed, they had survived the impact of the Halifax Explosion in 1917 (Figure 64). The handrails began to deteriorate in the 1960s and 1970s, as did much of the masonry wall (Figure 65). They were one of the last remnants of the North Street ICR Station. The handrails were removed in the 1980s and replaced with stronger and safer, more utilitarian handrails with a concrete cap at the bottom of the handrails (Figure 66). With the expansion of the sidewalk as part of the Barrington St. Complete Streets Project and the construction of the new retaining wall along side the old one, the handrails were removed between 2017 and 2019 and a chain-link fence with a concrete barrier was installed (Figure 67).

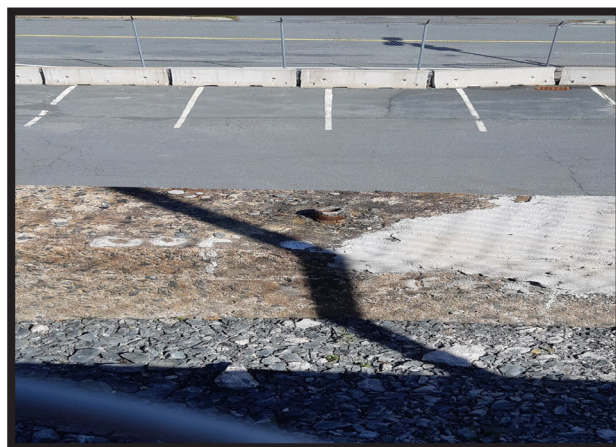
Figure 67: With the construction of the new retaining wall, the handrails were removed.
(Source: Maenza, 2019)
